INSTALLATION INSTRUCTIONS - INS052

1993 - 1997 GM LT1 CAMARO/FIREBIRD

UNDERDRIVE CRANK PULLEY

Part # 1591

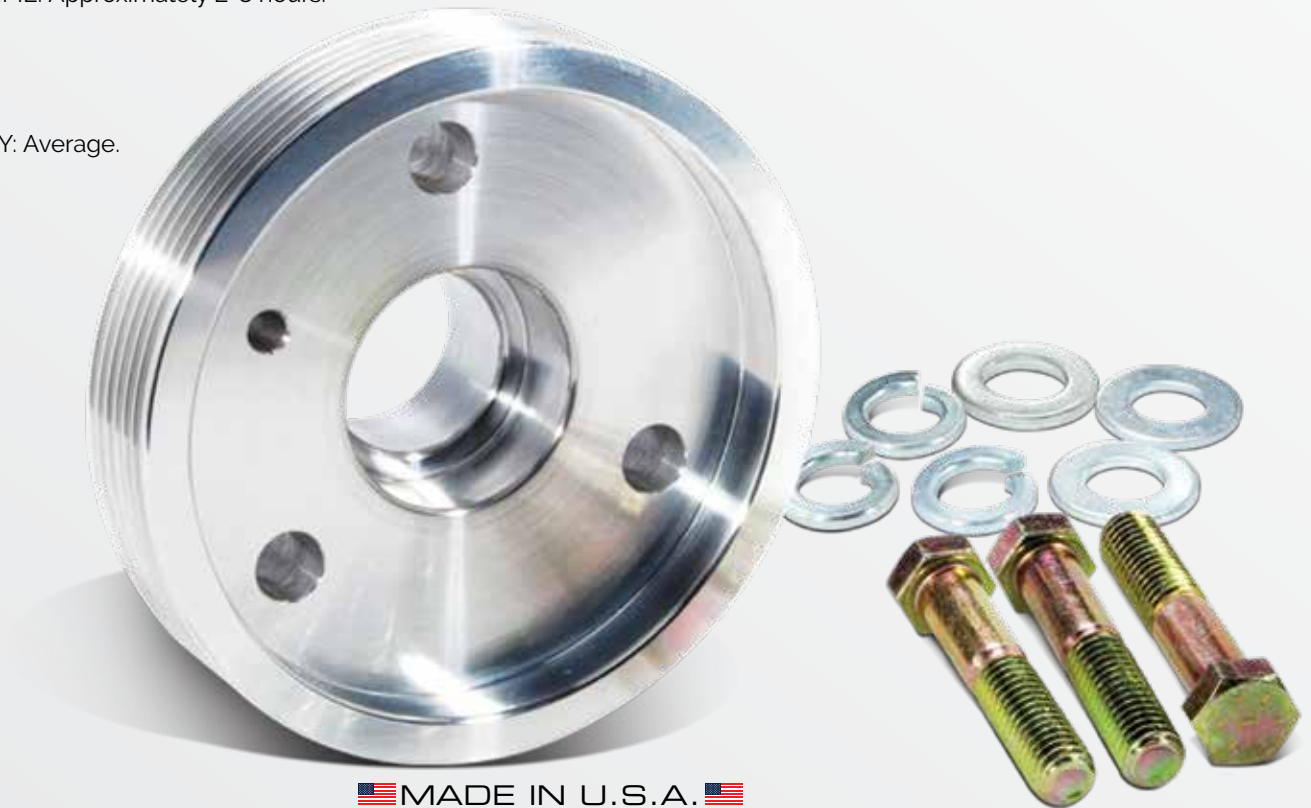
Re-assemble the new pulley, balancer/stock pulley and crank hub using the supplied 7/16" bolts, lock washers, and flat washers as shown in the diagram. Torque the bolts to factory specification (Approximately 60-80 ft/lbs).

Note the position of the line-up mark on the stock pulley/balancer, this will be lined up with the 1/4" diameter hole on the BBK pulley when re-installed.
